**REMOVAL PROGRAM
CHRONOLOGICAL SUMMARY REPORT
FOR THE
MILLER INDUSTRIES 348 LINCOLN STREET SITE
LEWISTON, MAINE
18 SEPTEMBER 2003**

Weston Solutions, Inc.
Region I
Superfund Technical Assessment and Response Team 2000 (START)
37 Upton Drive
Wilmington, MA 01887

January 2004

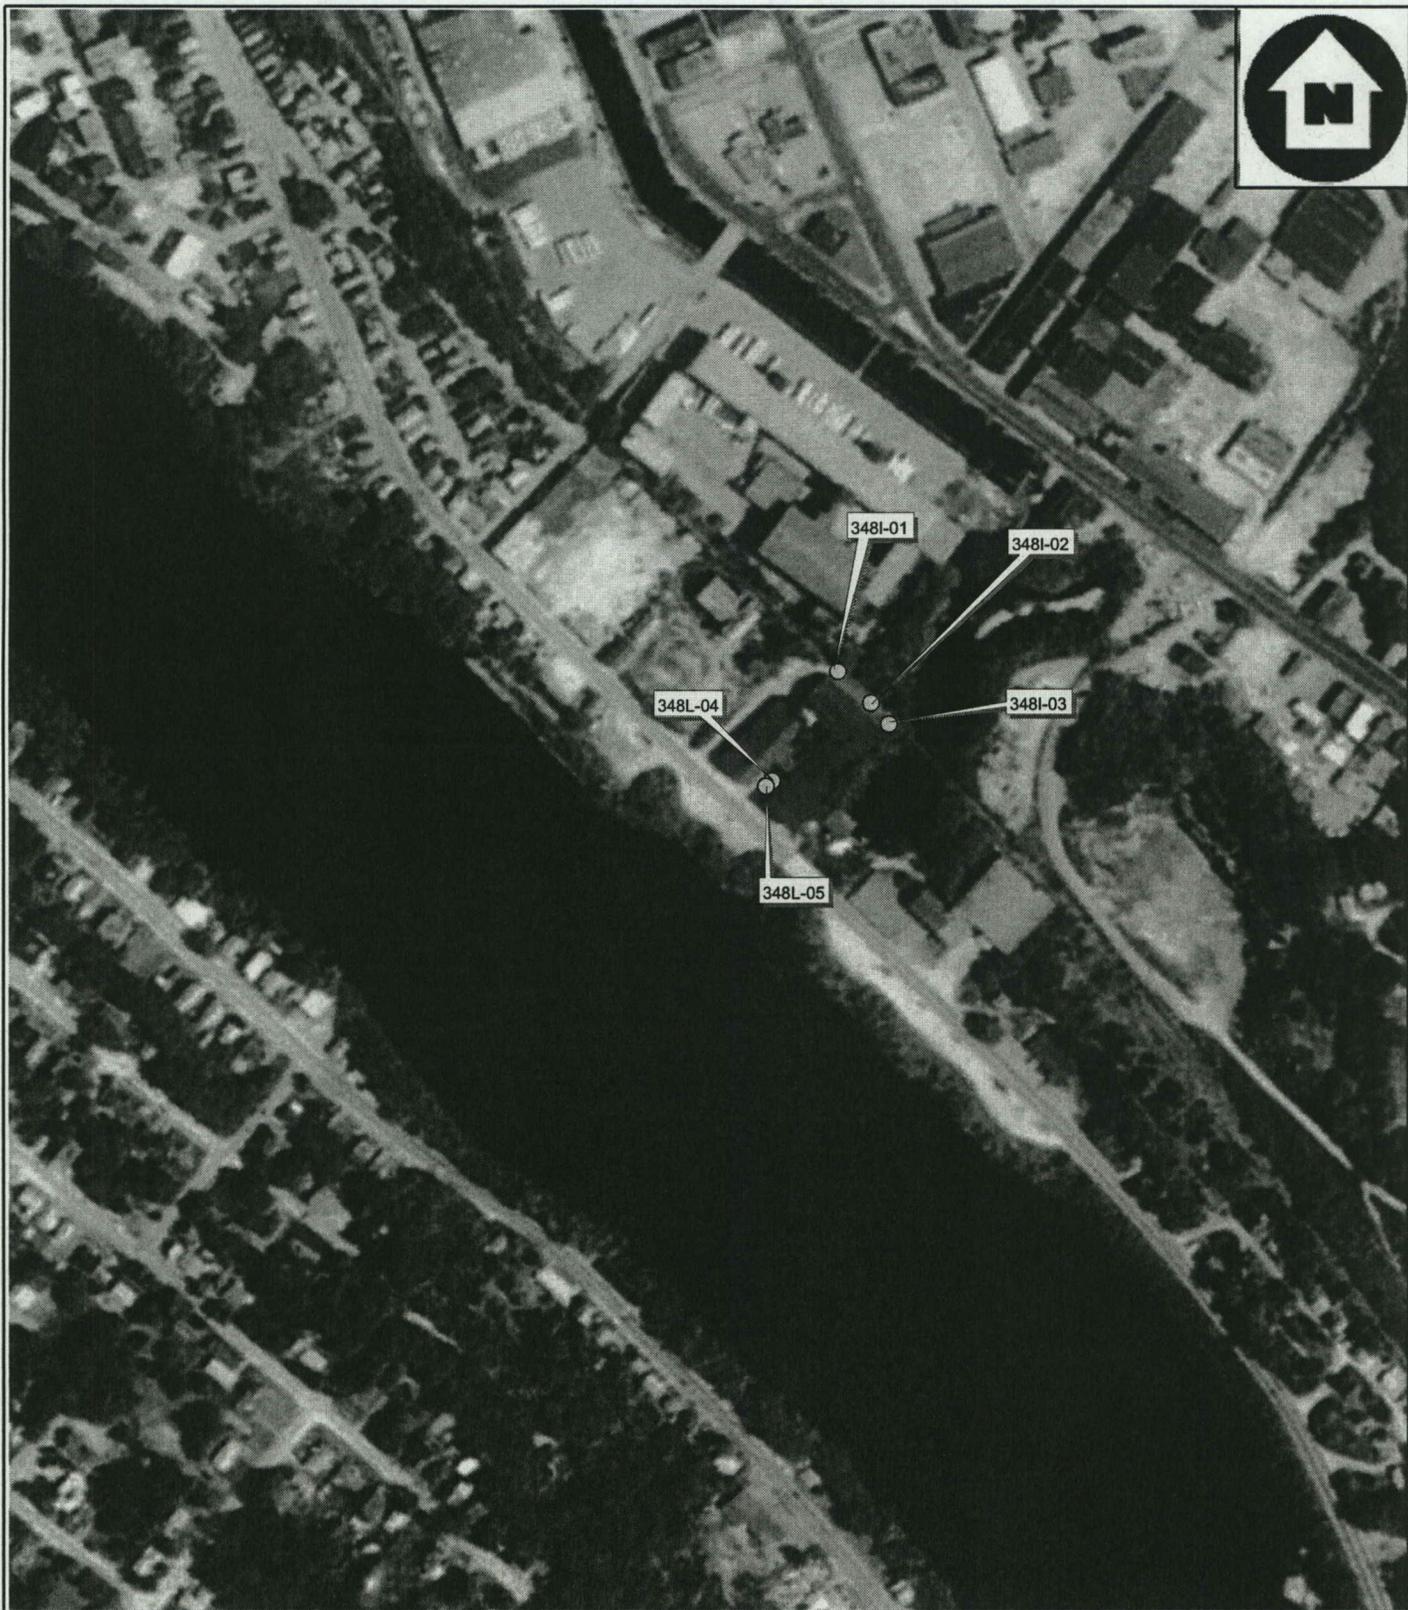
Sample Location Diagram (Figure 2)

SAMPLE LOCATION DIAGRAM

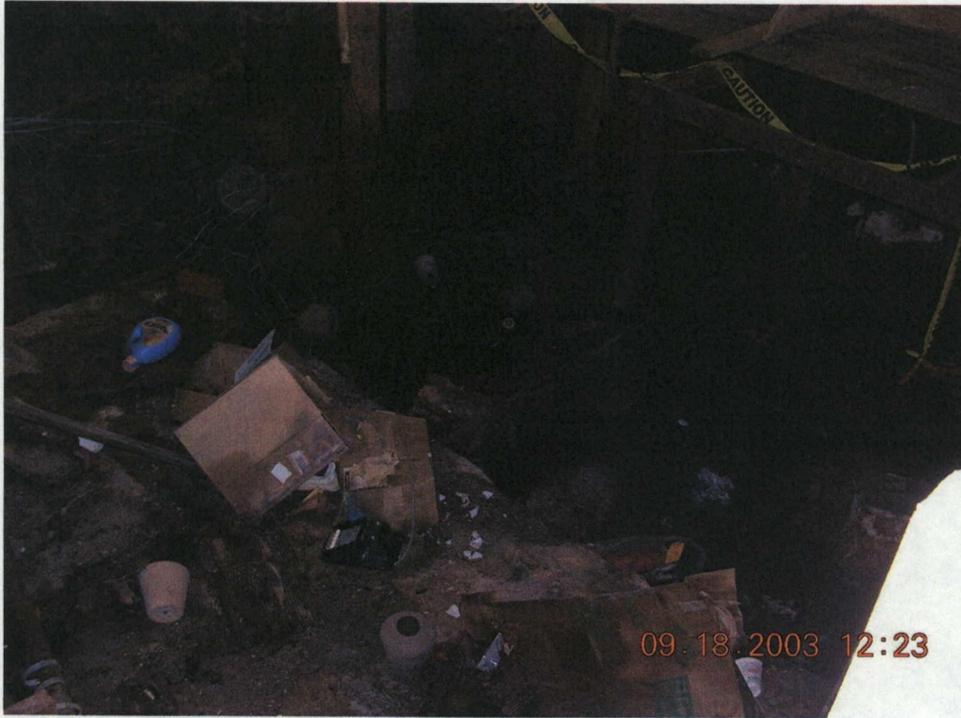
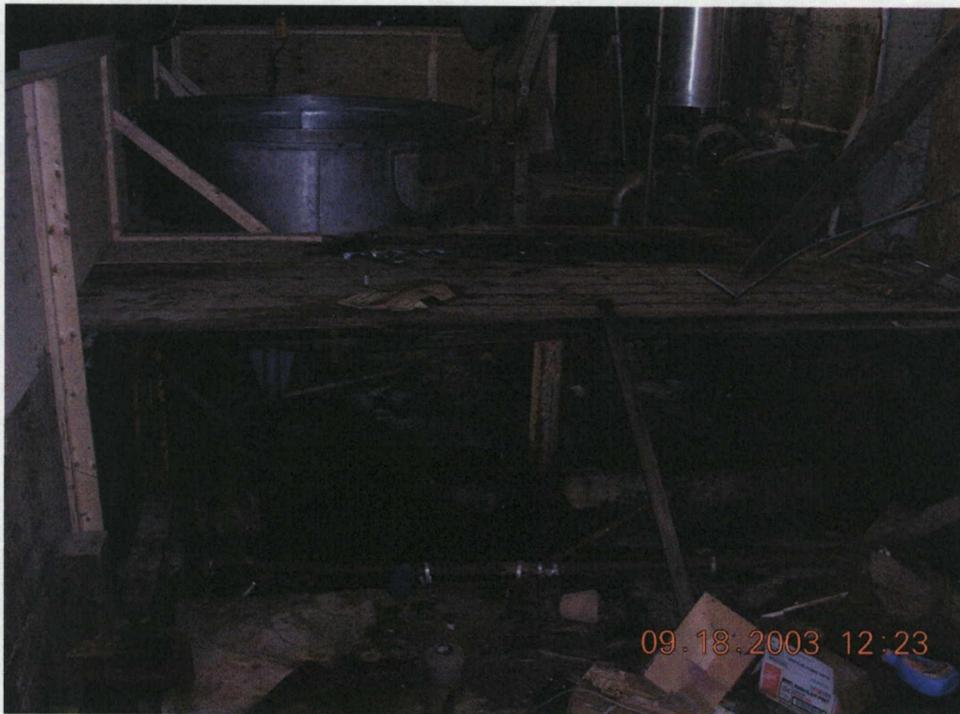
SCENE: View of the dye vat pit inside the mill building, sample location PIT-01.

One dye vat pit was observed on the first floor of the building, and drums of hazardous materials that were collected from areas within the building, and which have reportedly been sampled, were observed to be staged in a containment area on the first floor. A portion of the mill building was observed to be used for storage by Miller. Electric power was operable within the mill building, and suspected ACM was visible on the first floor. A purple-colored dye was observed to be emanating from cracks in the concrete slab floor near the dye vat pit.

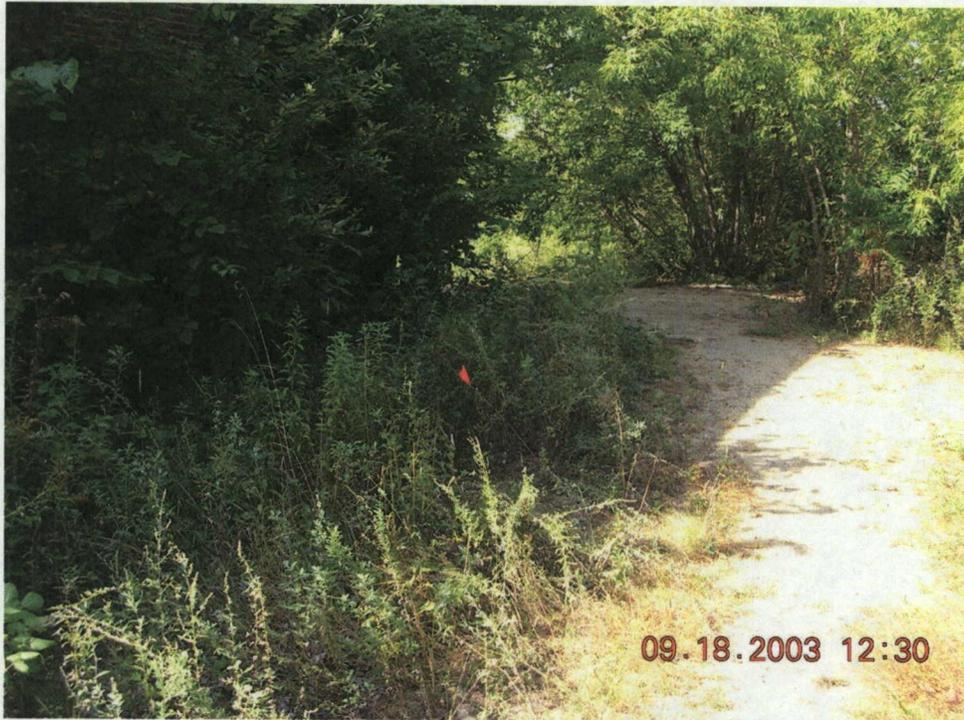
SCENE: View of sample location SS-01, located along the northern perimeter of the mill building. Photograph taken facing northwest.

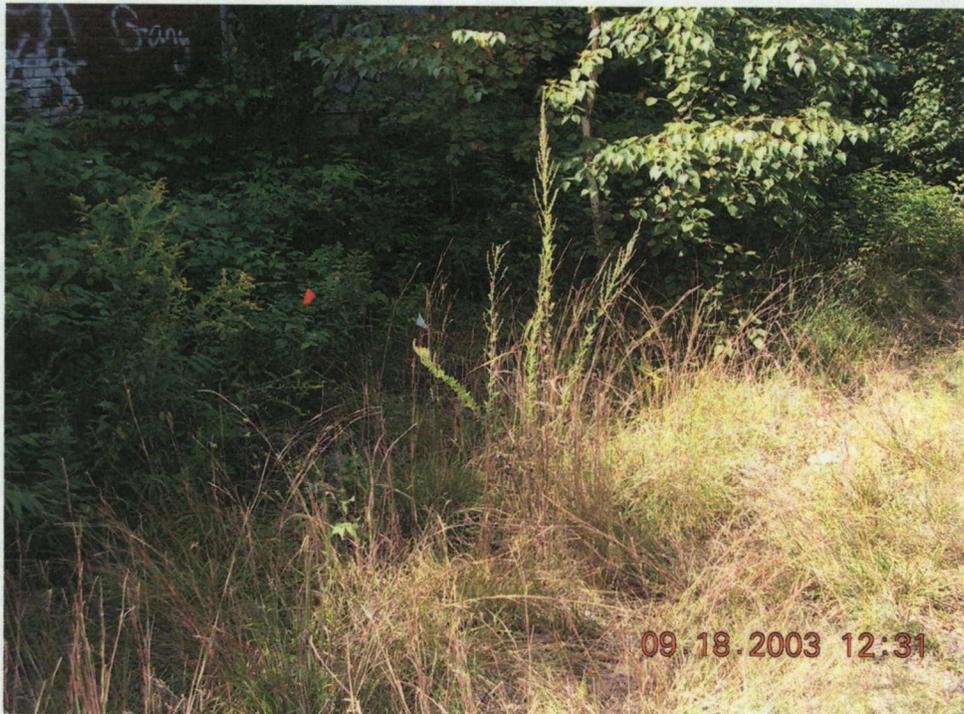
SCENE: View of sample location SS-02, located along the northeastern perimeter of the mill building. Photograph taken facing west.

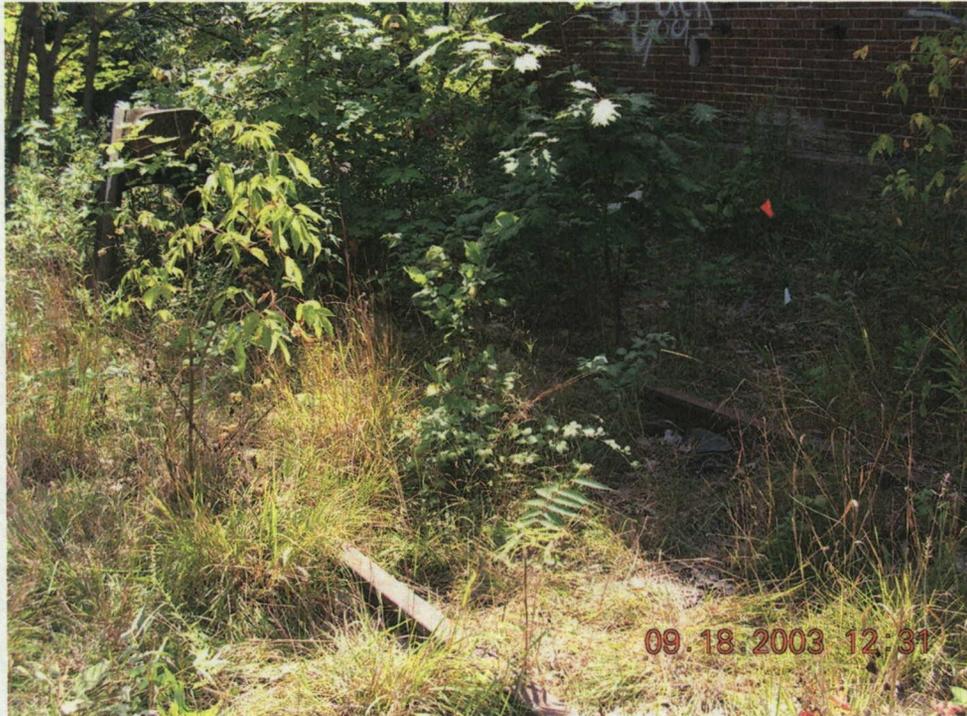
SCENE: View of sample location SS-03, located along the eastern perimeter of the mill building. Photograph taken facing southeast.

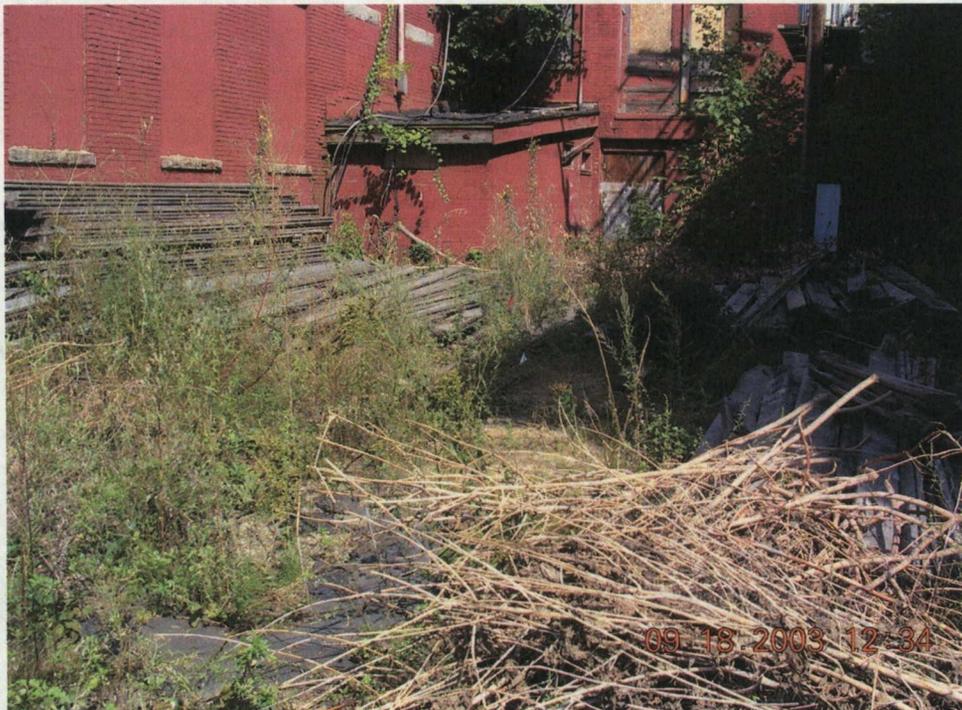
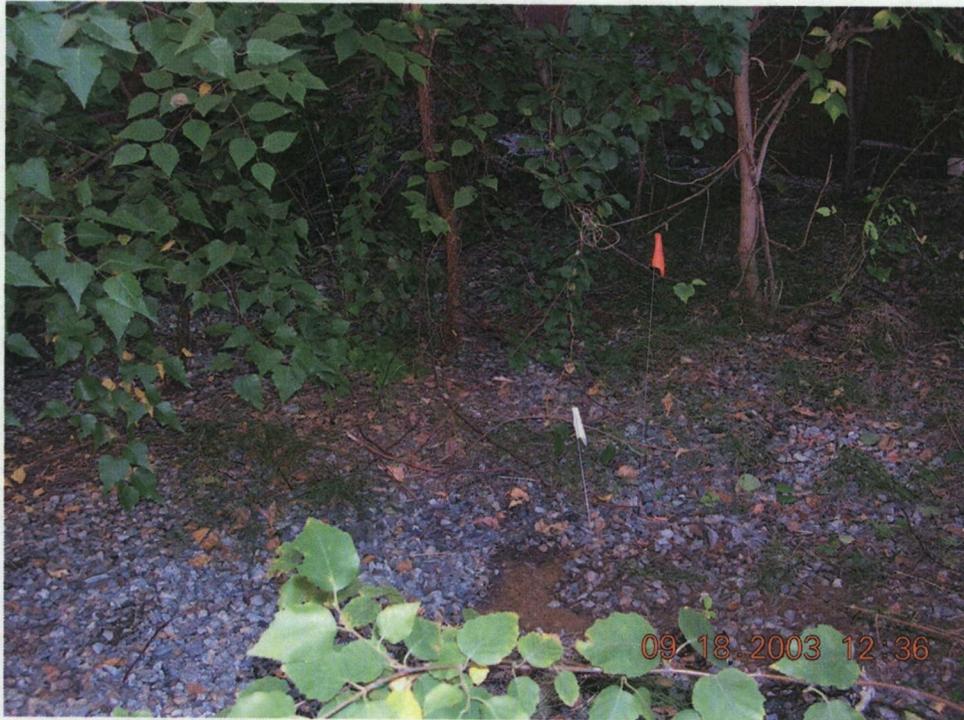
SCENE: View of sample location SS-05, located in the courtyard on the southwest side of the mill building. Photograph taken facing northwest.

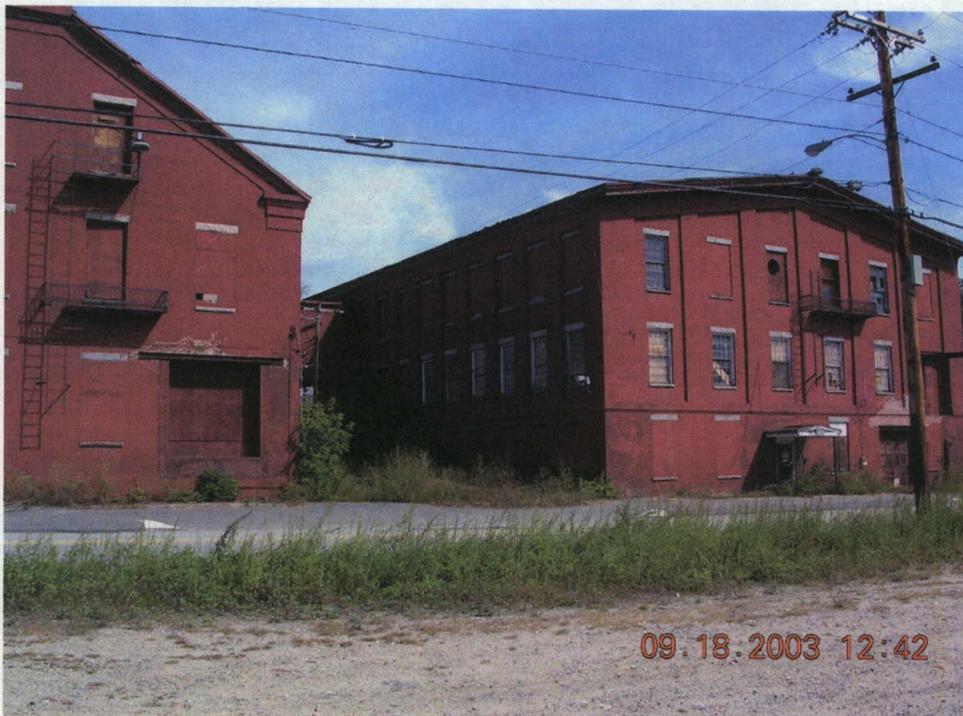
SCENE: View of the mill building from the opposite side of Lincoln Street. Photograph taken facing northeast.

A walk-through of the site was conducted by all site personnel. Areas along the perimeter of the on-site building were observed to be paved. The topography of the site sloped from the southwest side of the property toward Lincoln Street. Railroad tracks are located adjacent to the northeast portion of the site. The on-site building is a three-story brick structure which appears to be in fair condition.
